## W3150A+/W5100 Errata Sheet

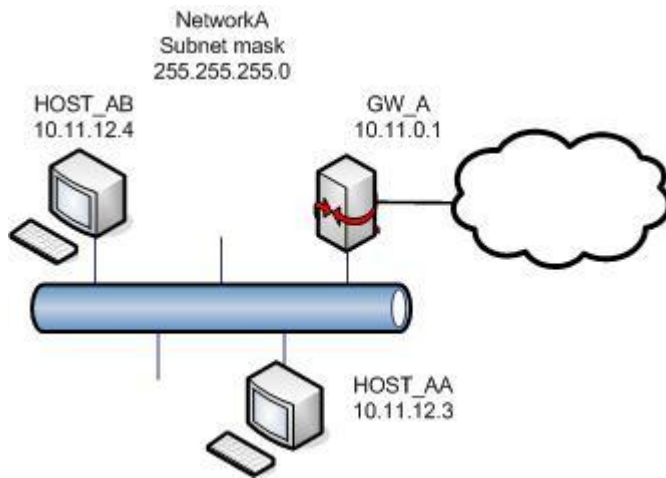
**Figure 1. General network**

**Phenomenon** Unable to complete SEND/SENDMAC command in UDP/IP-Raw mode. That is, do not assert SEND\_OK interrupt and do not equal the values of Socket n Tx Read Pointer Register (Sn\_TX\_RD) and Socket n Tx Write Pointer Register (Sn\_TX\_WR).

**Condition** Generally, the Sn\_TX\_RD value is equal to the Sn\_TX\_WR value and asserts SEND\_OK interrupt when a transmission process was completed. But the case of errata which the Sn\_TX\_RD and Sn\_TX\_WR values are different and do not assert SEND\_OK interrupt in UDP/IP-Raw mode. This phenomenon is occurred when our chip receive data in opened socket (i.e. assert RECV interrupt) and simultaneously the application program (Host MCU) executes SEND/SENDMAC command on that socket.

In Figure 1 network,

1. Open UDP socket in AA. Port number is 1000.
2. Send UDP data packet(destination port number 1000) from AB to AA.
3. AA processes the UDP data packet from AB.
4. Host MCU in AA runs SEND command to send.

When completion of 3 in AA (i.e. AA assert RECV interrupt), AA also runs 4 (i.e. run SEND command). In that case, do not complete process 4 due to errata.

| Solution | <p><b>In case of W3150A+,</b></p> <p>If you can monitor the RXDV signal (in MII interface), you can solve this problem.</p> <p>Before you execute SEND/SENDMAC command in UDP/IP-Raw mode, check the value of RXDV signal is '0'. That means there is no received data packet, so you can avoid the errata condition.</p> <p>Refer to following pseudo-code.</p> <pre>/* Change sendto() function */ Function sendto() { ... While (RXDV == '1') ; SEND command; /* Complete Sending */ }</pre> |
| Recommendation | <p><b>In case of W5100,</b></p> <p>We don't have solution but we can give a recommendation.</p> <p>After complete a transmission process, check whether Sn_TX_RD and Sn_TX_WR have same values or not. If both values are still different, close the socket and reset by force.</p> <pre>/* Change sendto() function */ Function sendto() { ... /* Complete Sending */ /* wait until Sn_TX_WR and Sn_TX_RD are same */ While (Sn_TX_WR != Sn_TX_RD) { wait some time; loop_cnt++; if (loop_cnt &gt; CONST_BLOCK_CNT) goto RESET } }</pre> |

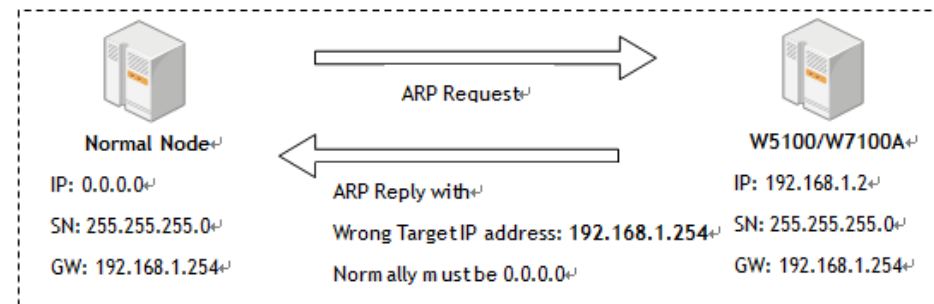
The W5100 replies with gateway IP address for the ARP request from network node which has "0.0.0.0" IP address. But normally the W5100 should replies with target IP address "0.0.0.0" not the gateway IP address.

The main reason of this erratum is subnet calculating logic. The W5100 misunderstands the node locates other sub-network when target has "0.0.0.0" IP address. So the W5100 set the target IP to the gateway IP instead of "0.0.0.0" and sends the ARP reply.

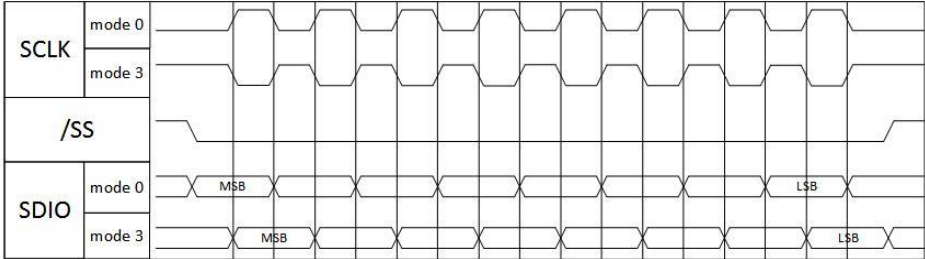
| Errata 4 | |
|---|---|
| Phenomenon | Not support SPI mode 3 with a bug |
| Condition | <p>The documents of W5100 and W3150A+ said that it supports two SPI modes (mode 0, 3).</p> <p>The below figure shows the Timing diagram in SPI mode 0 and mode 3.</p> <p>But now, W5100 and W3150A+ do not support SPI mode 3 with a bug.</p> |

| Errata 4 | |
|---|---|
| Solution | Not support SPI mode 3 |
